भारत का राजपत्र The Gazette of India

“पश्चिम बंगाल राज्य, बुर्दवान जिले में न्यू केन्डा कोलियरी में 25 जनवरी, 1994 को घटित दुर्घटना के लिए जांच न्यायालय की रिपोर्ट।”

मेसर्स ईस्टर्न कोलफील्ड्स लिमिटेड
की
न्यू केन्दा कोलियरी में
25.1.1994 को हुई दुर्घटना के
कारणों तथा परिस्थितियों की
जांच - रिपोर्ट

**THE REPORT OF INQUIRY INTO THE
CAUSES AND CIRCUMSTANCES
ATTENDING THE ACCIDENT
ON 25.1.1994
AT NEW KENDA COLLIERY
OF
M/S. EASTERN COALFIELDS LIMITED**

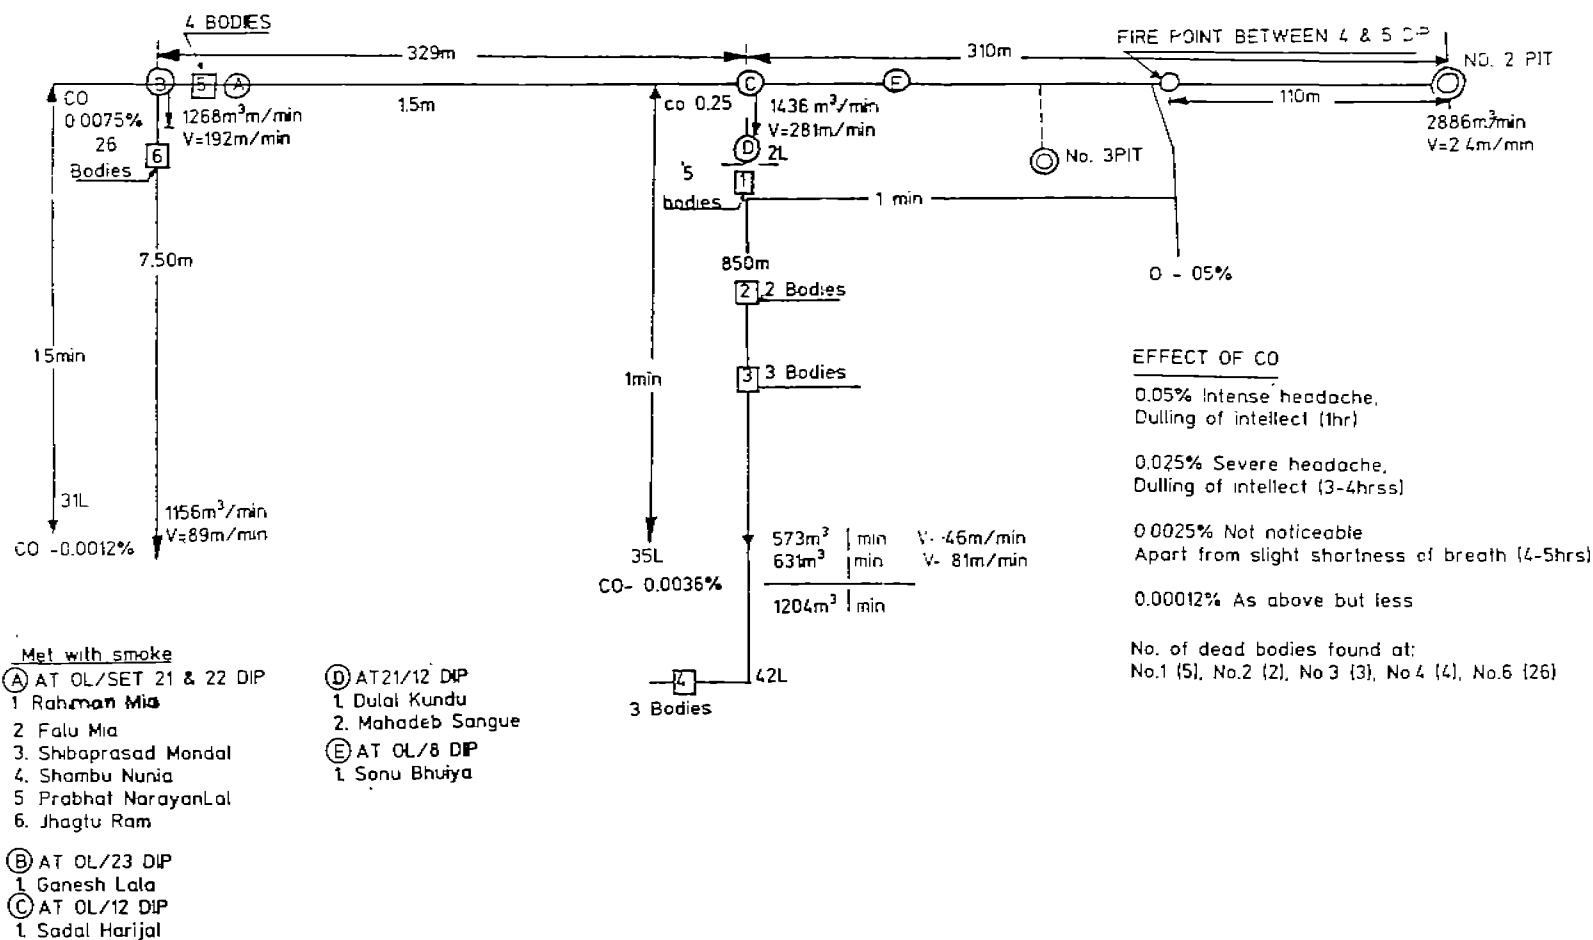
**VENTILATION SYSTEM (SCHEMATIC) AND
LIKELY DISTRIBUTION OF CO DURING FIRST FEW MINUTES OF EVENT
DUE TO BURNING OF 1kg OF COAL
PRODUCING 15³m OF CO**

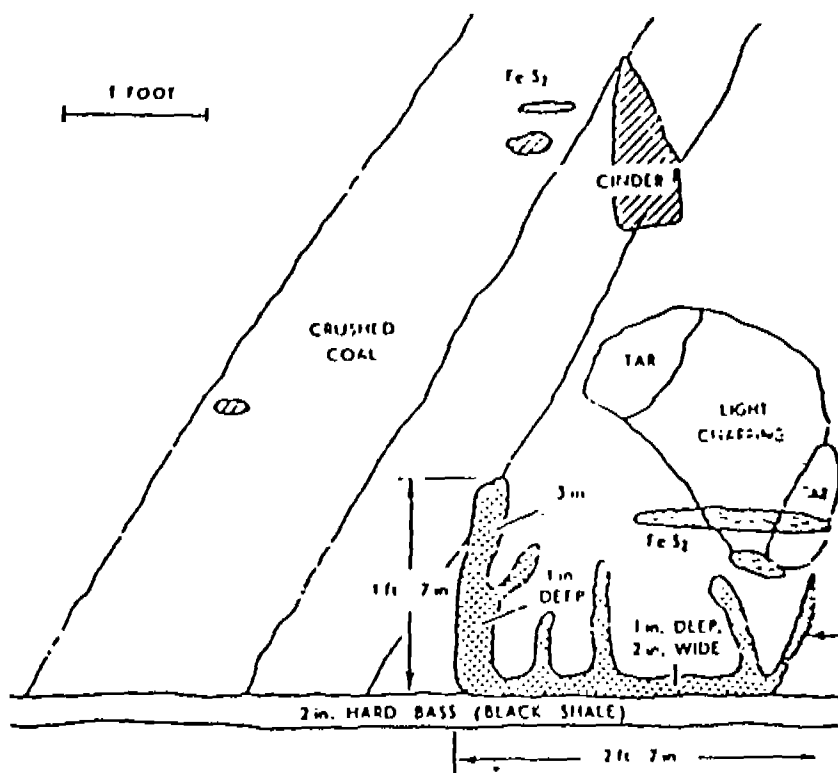
FIG. 13

SITE OF A SMALL HEATING IN A BREAK IN A COAL SEAM
(JONES & VALLIS)

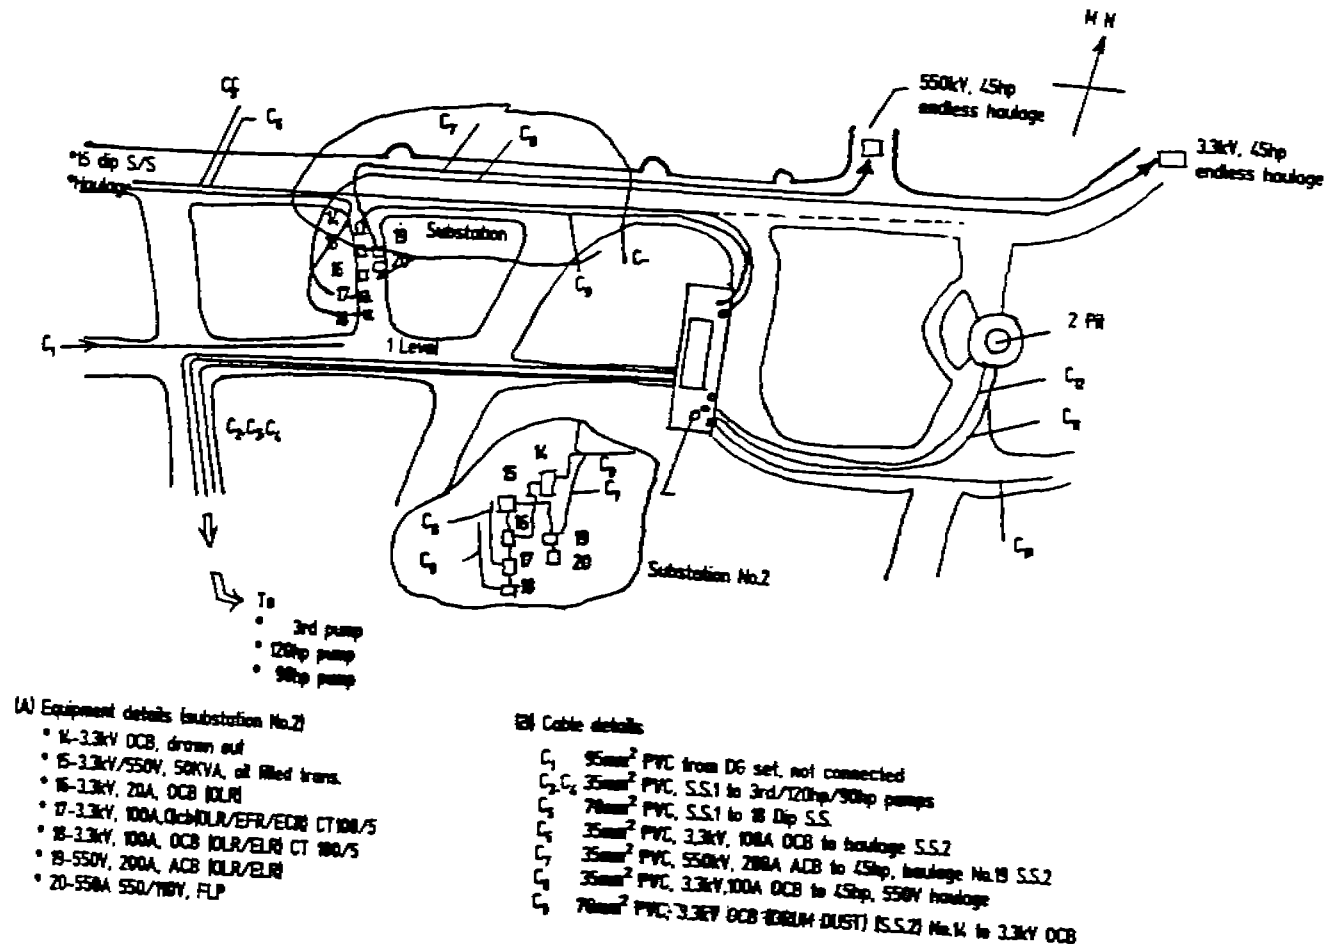
Fig.1 : Main Fire zone with respect to the electrical equipment and cables

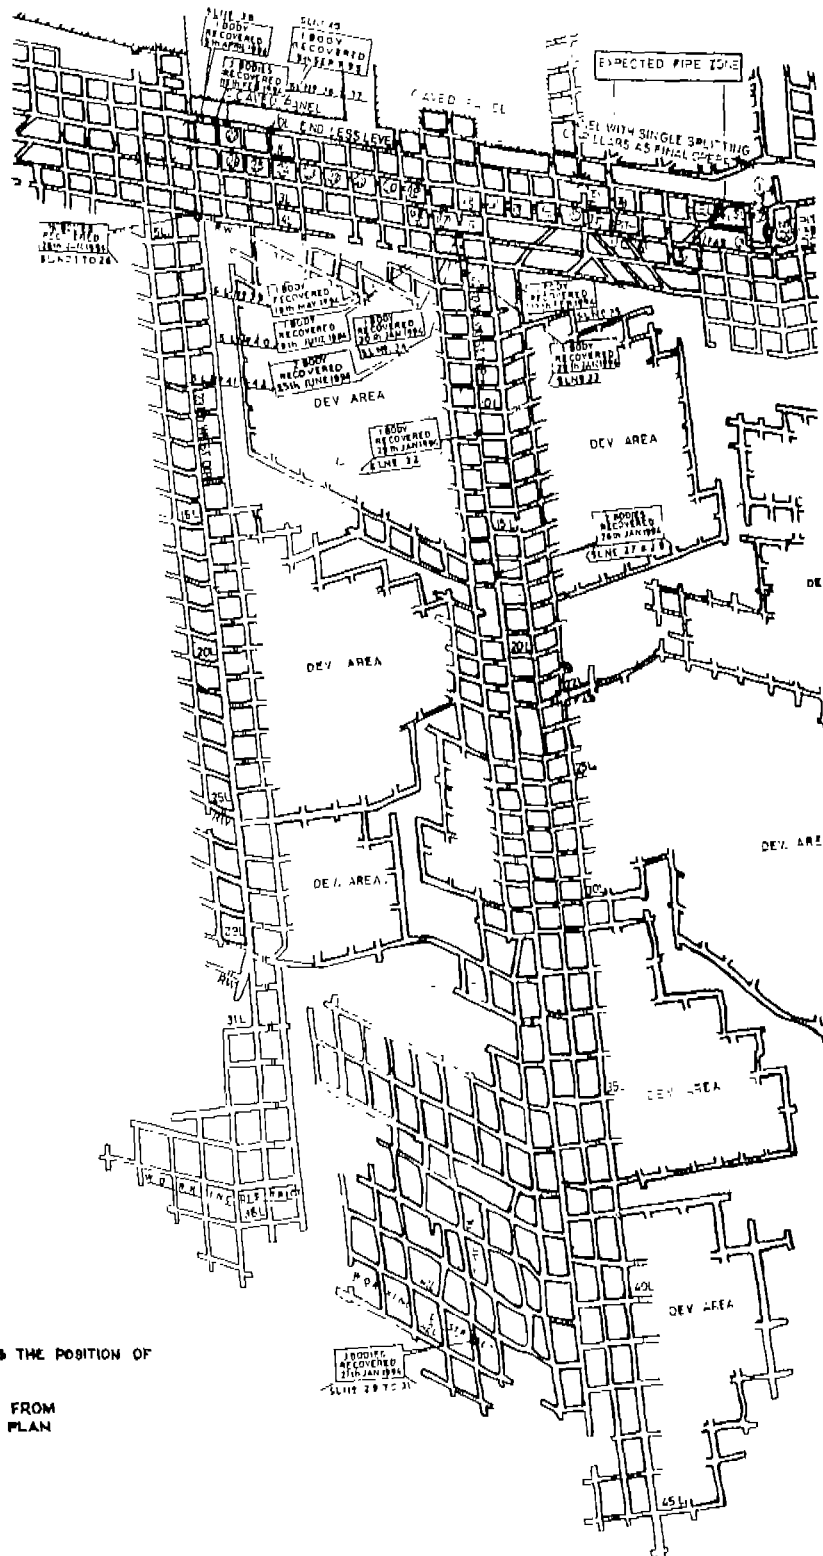
PLAN SHOWING THE POSITION OF
DEAD BODIES.
